DEPARTMENT OF TRANSPORTATION

Quality Assurance and Source Inspection

OBG # TRIAL ASSEMBLY YARD

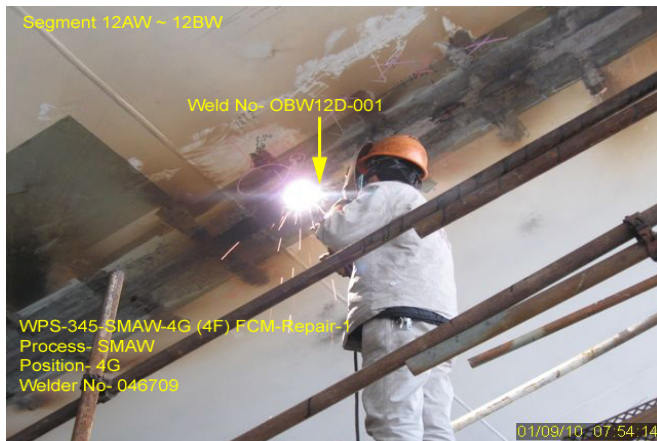
Segment 12AW ~ 12BW

This QA Inspector observed ZPMC qualified welding personnel identified as 046704 perform Shielded Metal Arc Welding (SMAW), weld joint identified as OBW12D-001; located On Orthotropic Box Girder (OBG) Bottom Plate to Bottom Plate CJP Weld; The Critical Welding Repair Report (CWRR) was B-CWR2707. ZPMC Quality Control (QC) is identified as Mr. Shi Lei. The welding variables recorded by QC appeared to comply with applicable WPS-345-SMAW 4G (4F) FCM-Repair-1. See attached photo for further details.

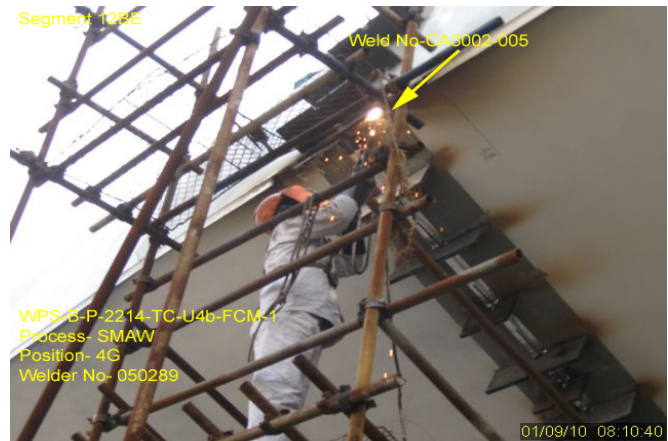
Segment 12BE

This QA Inspector observed ZPMC qualified welding personnel identified as 050289 perform Shielded Metal Arc Welding (SMAW), weld joint identified as CA3002-005; located On Orthotropic Box Girder (OBG) Side Plate to Edge Plate CJP Weld; ZPMC Quality Control (QC) is identified as Mr. Shi Lei. The welding variables recorded by QC appeared to comply with applicable WPS-B-P-2214-TC-U4b-FCM-1. See attached photo for further details.
